REPORT NO. EVT 42-87

HEMTT SLING ANGLE FOR THE DOUBLE
BASKET CHAIN SLING

EVALUATION DIVISION
SAVANNA, ILLINOIS 61074-9639

US ARMY DEFENSE AMMUNITION
CENTER AND SCHOOL

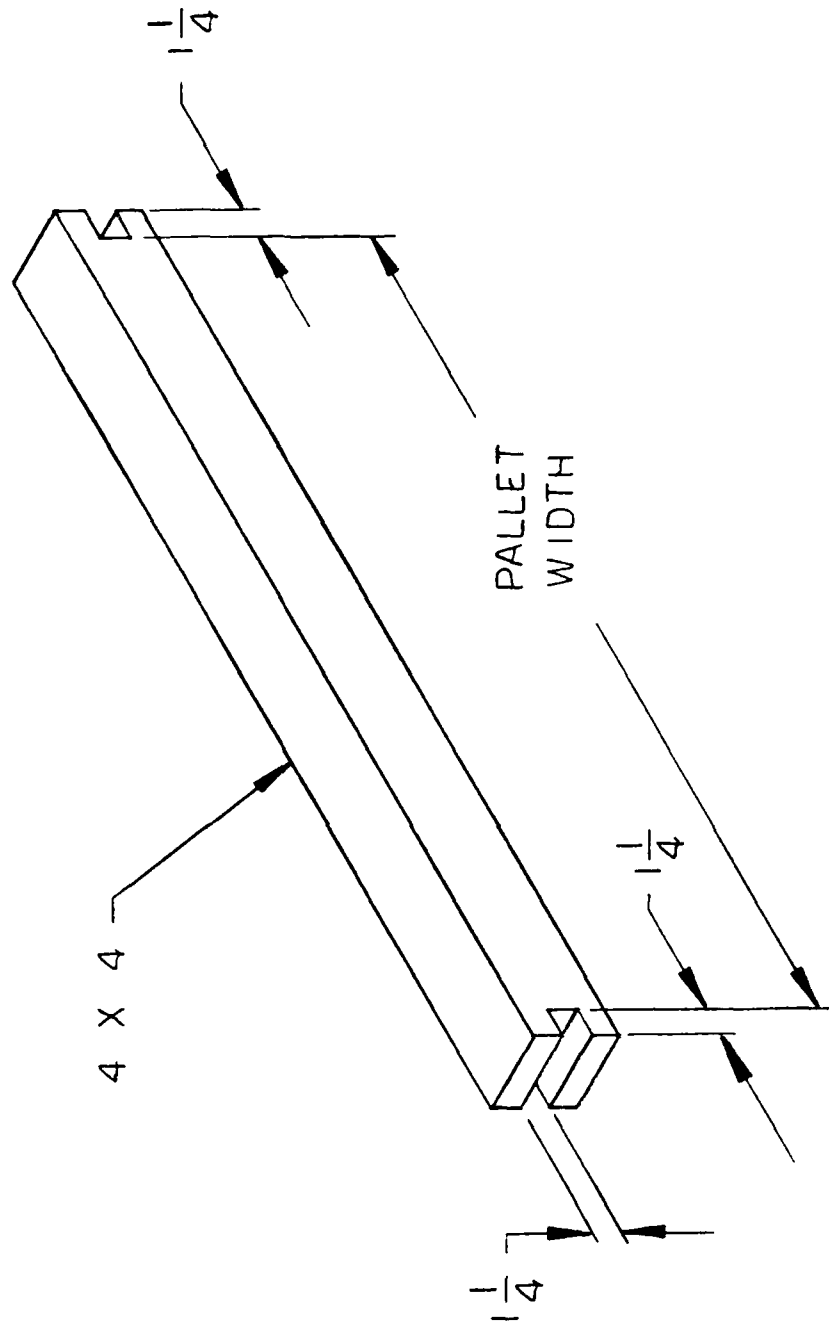
Figure 1
Spreader Bar

C. The use of spreader bars to reduce chain pressure at the top of the pallet will not create unsafe material handling conditions as long as the spreader bars are properly designed (see Figure 1).

B. If spreader bars are used on a voluntary basis, the maximum space between notches in the spreader bar should be pallet width or less, and limited in use to situations where proper rigging procedures cannot be followed and minor container damage is to be avoided. The use of spreader bars that have notches wider than the width of the pallet could result in unsafe material handling conditions.

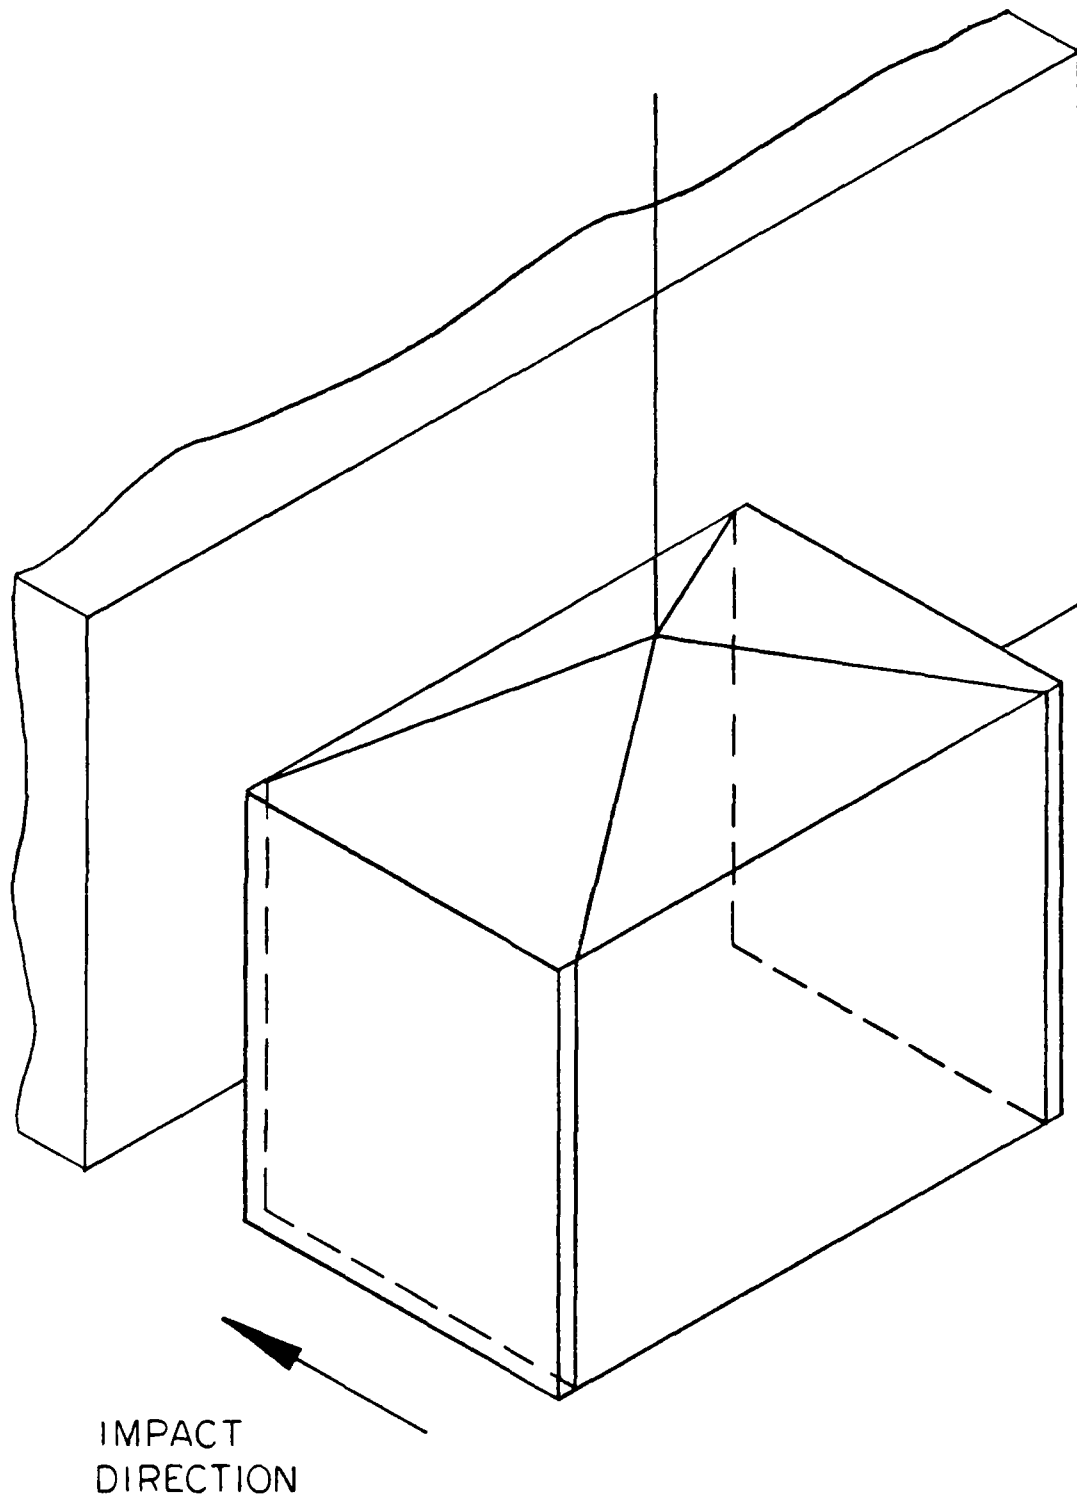
Figure 2

E. Slew Impact With the Wall Test. This test was conducted three times. In the first test, the chain slings were perpendicular to the impact surface (figure 2, page 7-2) with the pallet one foot off the ground prior to impacting the wall. In the second test, the chains were parallel to the wall (figure 3, page 7-3). In the final test, the chains were again perpendicular to the impact surface, with the impact at skid height simulating a pallet hitting a curb or the top of a second pallet.

INDICATES CHAINS PERPENDICULAR TO IMPACT
SURFACE

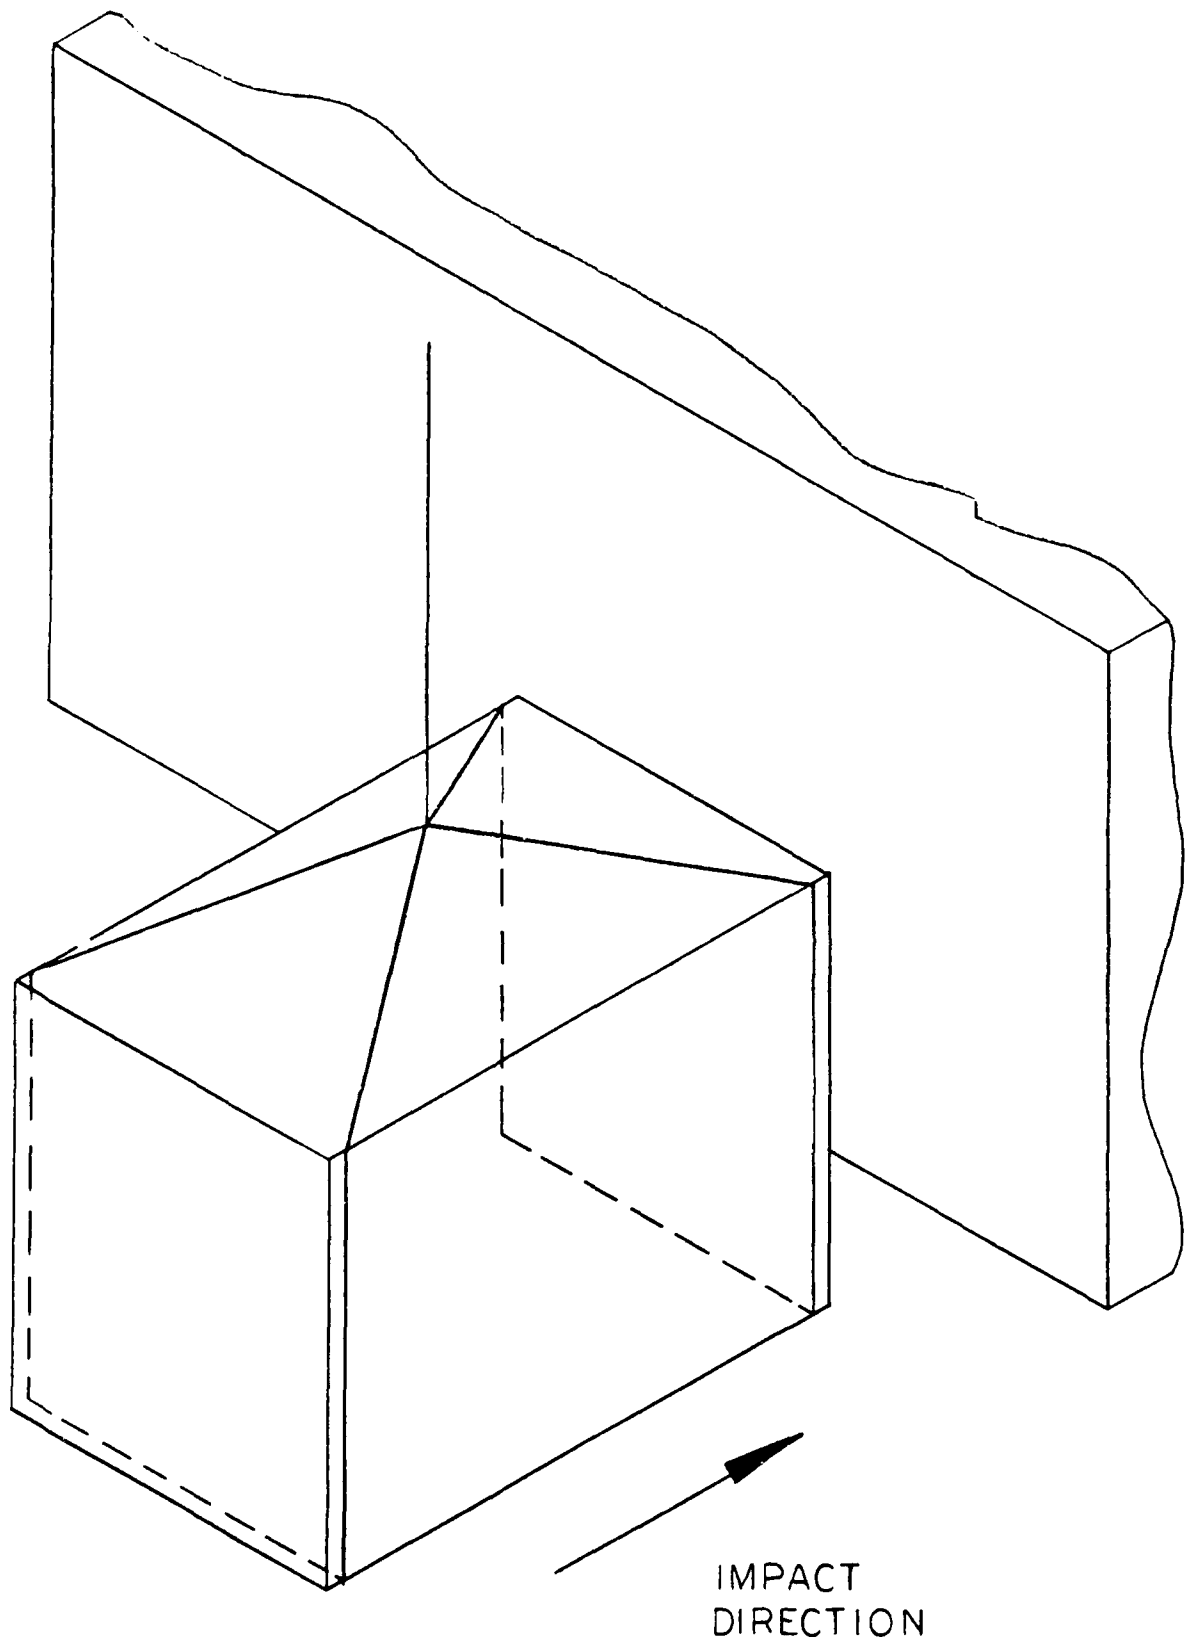
Figure 3

INDICATES CHAINS PARALLEL TO IMPACT SURFACE
